Report of the joint MIPP/PPD RICH Panel [1] on the RICH Accident of March 14,2004

(Dated: April 14, 2004)

We analyze the circumstances surrounding the accident of March 14, 2004 in the MIPP experiment. We show conclusively that the event was due to a fire in the photomultiplier box of the Ring Imaging Cherenkov (RICH) detector. We analyze the probable causes and recommend remedial steps designed to prevent similar recurrences in the detector.

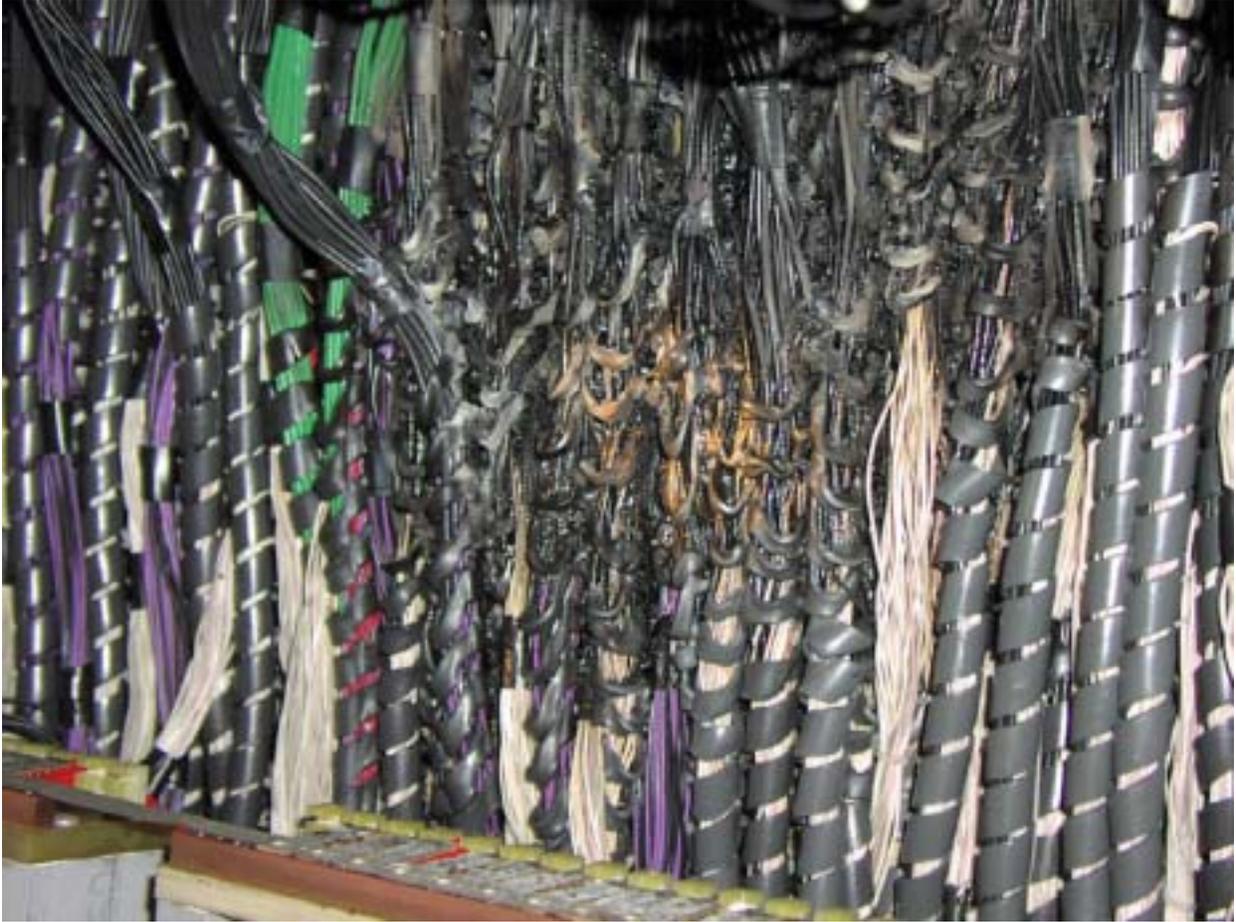
The readout cards were first checked and all were found to be functional. This implied that the source of the smoke was very likely in the pmt box. The RICH was pulled back from its nominal position in the experiment and the pmt box was opened up. It was discovered at this time that the cooling ducts that supply the cooled air into the pmt box were hooked up in reverse order [5] such that the airflow was from top to bottom and that the mixing fans were not hooked up. It was discovered that there was a bunch of cables in the pmt box that looked melted at the surface(see Figure 2).

FIG. 2: The appearance of the photomultiplier box after opening up revealed a singed area to the right.

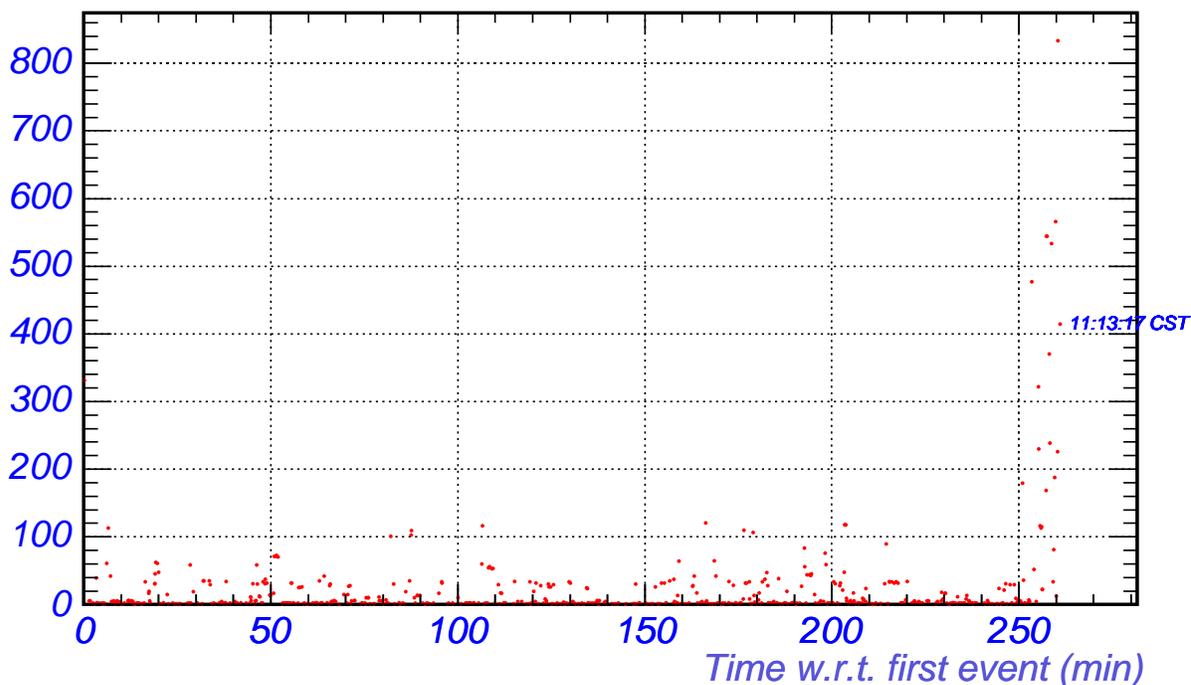
Number of RICH digits vs. time

The average number of phototubes hit per event is plotted as a function of time for the run that ended at 11:13:17 CST on March 14, 2004. This curve is flat until about 20 minutes before the end when a large number of hits are observed in the RICH. This behavior lent further support to the fire hypothesis. We then proceeded to call some arson experts from

FIG. 3: Average RICH hit multiplicity as a function of time for 250 minutes prior to the accident

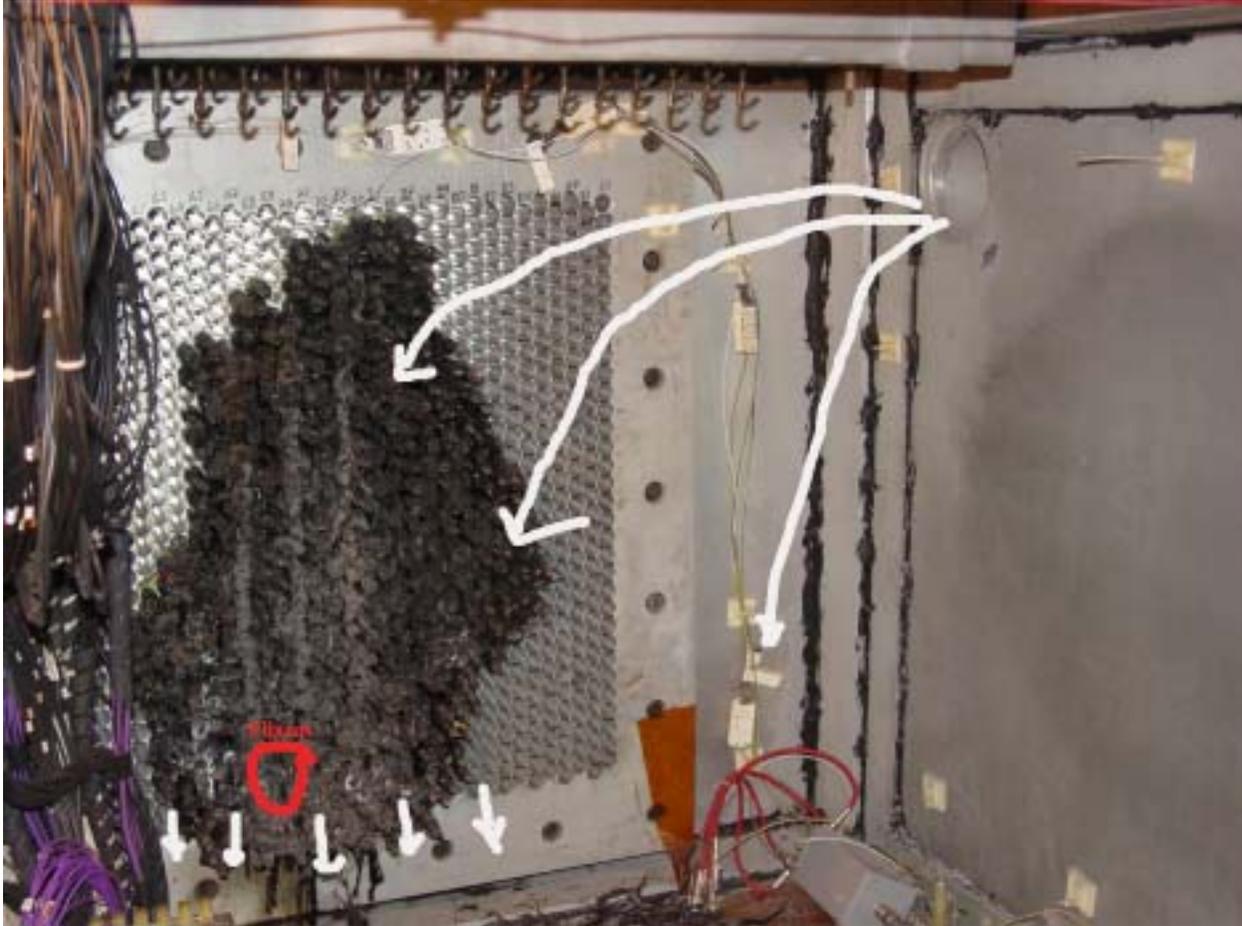
Further removing the cables from the affected area revealed the picture in Figure 4 that left no question as to whether there was a fire or not. A large number of phototube bases (≈ 500) were fused together and melted as a result of the fire. The condition of the tubes in this region is unknown and awaits further testing. The HV interlock was indeed found to be broken upon examination. So at least one of the klixons (clearly the burnt out one) exceeded 50°C .

FIG. 4: Appearance of the array after the removal of the burned cables. The bases of phototubes that fused together under the heat are shown. The approximate direction of the airflow at the time of the fire is shown by the arrows. The position of the temperature klixon that was burned is shown.

A visual examination of the fire region showed that the fire was most intense in column 73 a few rows from the bottom. This is probably the origin of the fire. It is worth noting that column 73 is a FEU-60 tube column.

- Reconstitute the klixon interlock. Replace the burnt-out klixon. This will prevent accidents due to overheated air.
- Inert the atmosphere in the pmt box by replacing the air with nitrogen. Monitor the oxygen content and report it to APACS.
- Detect current surges in the HV due to sparks and abort the HV supply output if sparks occur.
- Replace the flammable shrink-wrap around the FEU-60 tubes by a flame-retarded variety . In the process, reduce the risk of sparking and shorting in the base by applying a layer of insulating coating to the base (such as an acrylic conformal coating that can be sprayed on).

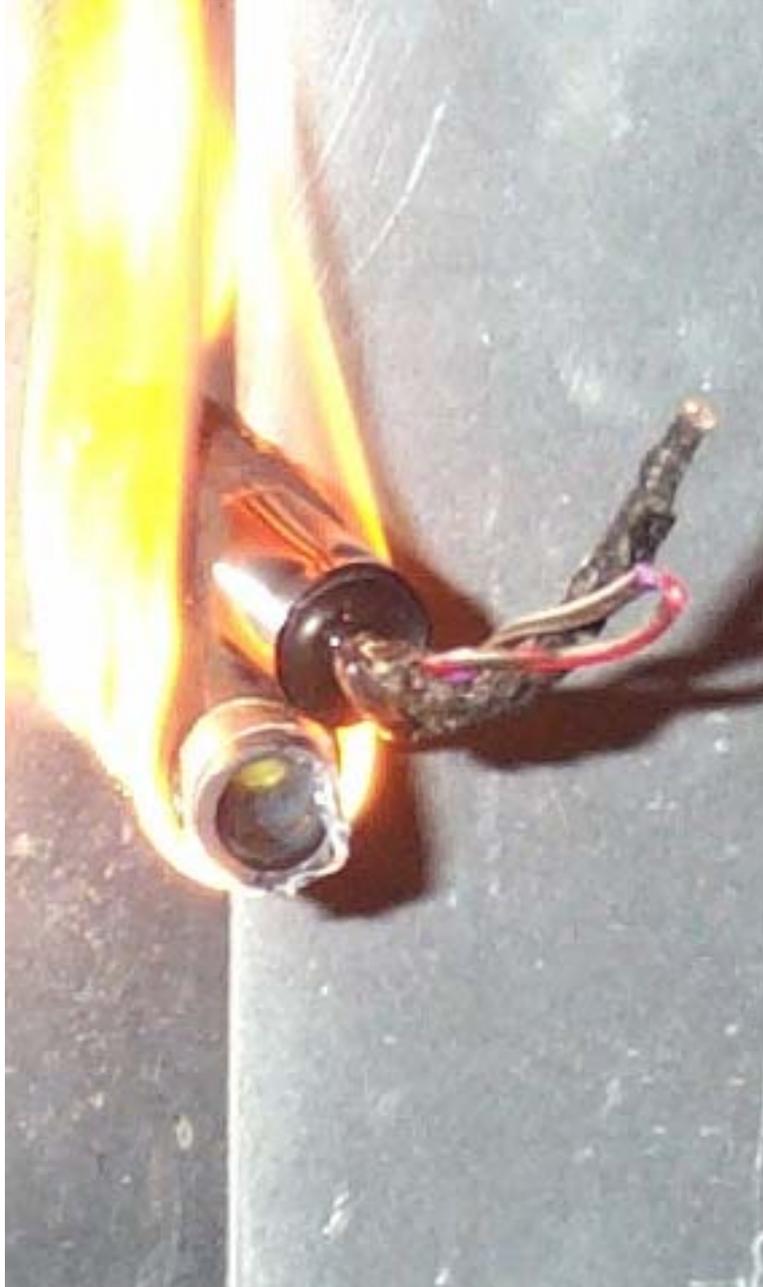
- The FEU-60 base burned rapidly to consumption in 2 to 3 minutes.
- The FEU-60 base dripped its burning material down spreading the fire and produced enough flame and energy vertically and horizontally, to rapidly spread the fire to adjacent units.
- The Hamamatsu R-760 base does not burn if left to itself. It needs the flame provided by the burning FEU-60 base to show evidence of charring.
- The less flammable Hamamatsu bases and the gap between the grates and the backward airflow most likely limited the fire because the FEU-60 bases were consumed rapidly in 2 to 3 minutes. The fire duration was most likely between 3 and 10 minutes.

Figure 5 shows the FEU-60 base in flames after the first test.

FIG. 5: The FEU-60 base is at the bottom and has caught fire as a result of a candle-like flame being applied for approximately 10 seconds. This picture is taken 25 seconds into the burn.
